EPSON Product Support Bulletin

Date:	April 2, 2007	Originator:	VS
PSB #:	PSB.2007.04.001	Authorization:	<i>[Signature]</i>
Reference:	TI 06-0491 Rev.B	Total Pages:	2
Product(s):	Expression 10000XL/1640 XL/1680/1600/800/836 XL, Perfection 3490/3590/4490/V700/V750/V100/V350/1240U/1250/1260/1640/1650/1660/1670/2400/2480/2580/3170/3200/4180/4870/4990/640U/1200U/610, GT-2500/15000/30000 series scanners		
Subject:	Scanning Application Force Quits on Mac OS 10.4

Date:	4/2/2004	Originator:	TC
PSB #:	PSB.2004.04.002	Authorization:	<i>Kps</i>
Reference:	N/A	Total Pages:	2
Product(s):	Perfection 3200 Series Scanner		
Subject:	LaserSoft Imaging™ SilverFast® Driver issues with Windows 2000 and XP

Date:	9/18/2003	Originator:	TC
PSB #:	PSB.2003.09.001	Authorization:	Kas
Reference:	N/A	Total Pages:	2
Product(s):	Perfection 3200 Series		
Subject:	Updated Epson Scan v. 1.21A for Macintosh OS 10.2.x

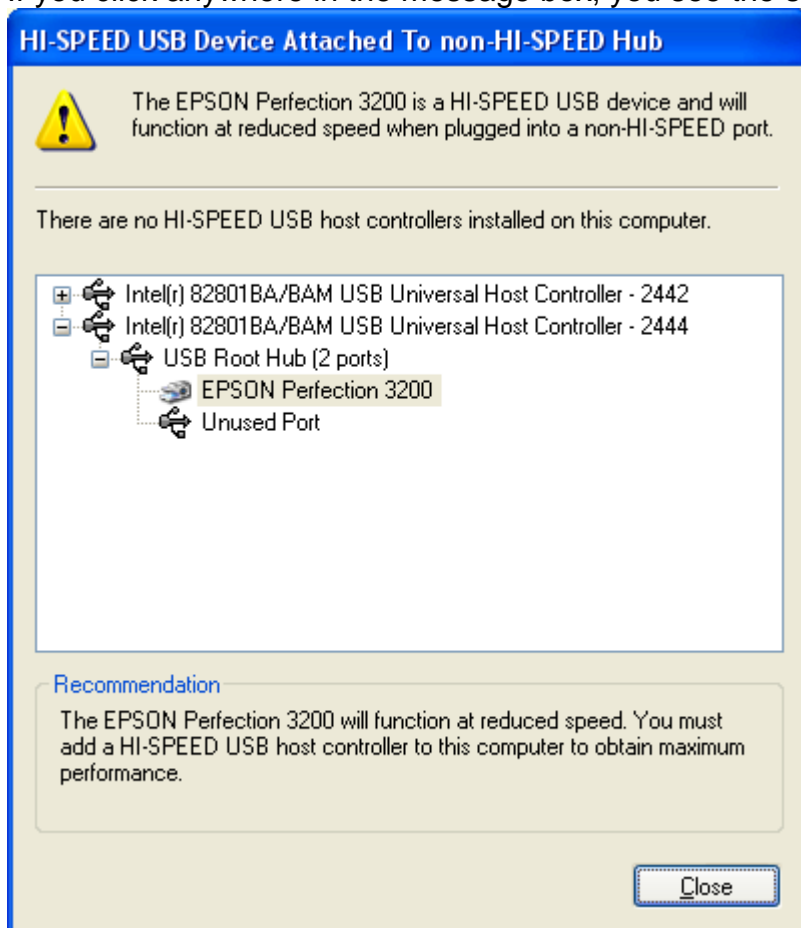
If you click anywhere in the message box, you see the screen below:

Click on the "Close" button to close the window.
